**RESPONSE TO CONSERVATION MANAGEMENT PLAN  
FOR FLETCHER JONES FACTORY AND GARDENS**

D.F.Jones  
December 2005

## Pleasant Hill Construction Stages

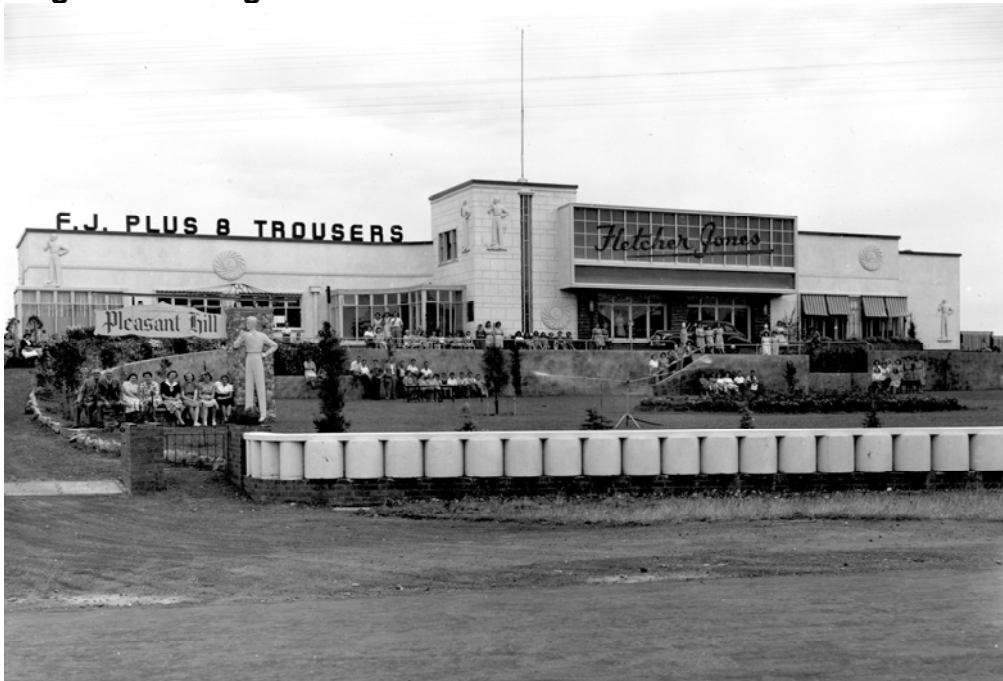
Photo 1

This photo was taken in 1948. It illustrates the cutting room on the left (formerly Darley camp post office) and the tower and front building (first canteen) which

was built on site as an addition to the Darley officers mess which formed the first machine room which was behind<sup>2</sup>. Note the use of aircraft anchors as the front fence and the repeated use of the FJ Man and Roundels.

**Current state:** These buildings have had massive alterations over the years – see the following pages.

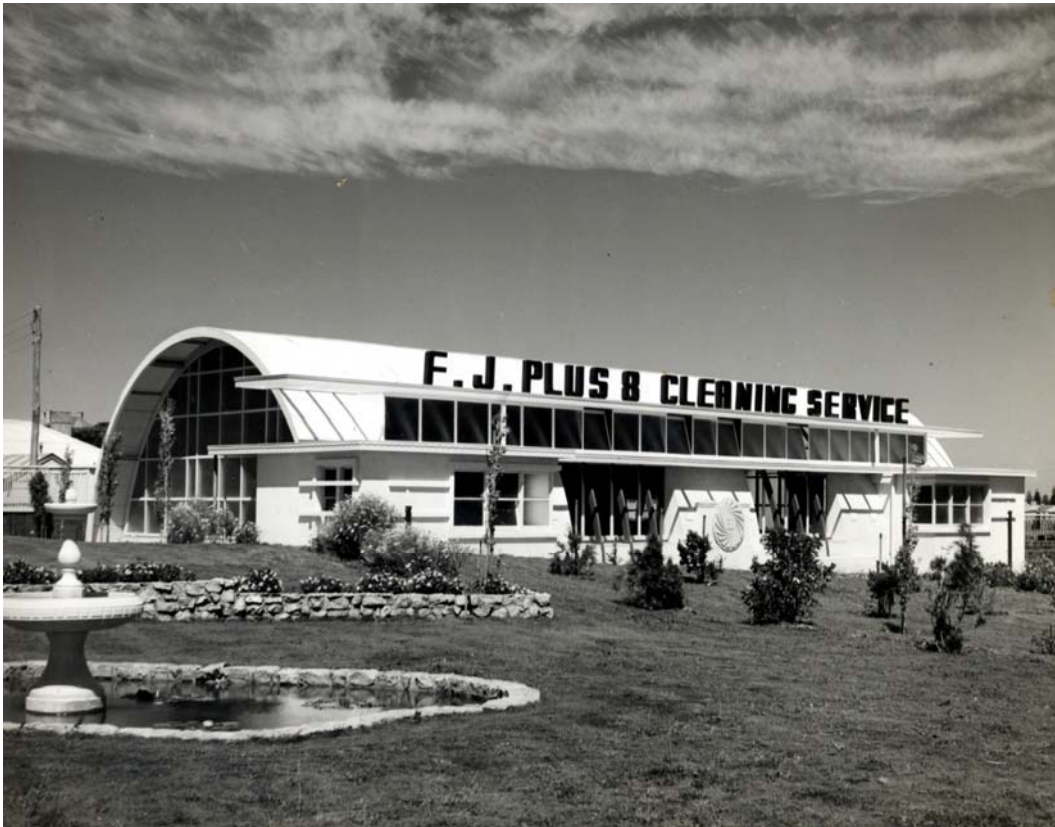
This photograph was taken in late 1949. Note house behind Quonset hut and fence. This land had not at this stage been acquired by the Company.

**Current state:** The Quonset hut is in good condition. It is hidden by the walkway to the Women's Wear factory to the west and has had extensions added to the west and south sides. These extensions have not altered the fundamental fabric of the structure. The roundel shown on the face is still in existence.<sup>3</sup>

I agree that the walkway should be removed and the building restored to its original appearance. Photo 2 – page 3. The roundel on the front is still in existence.

I would favour removing the extension to the Quonset hut at the west end which was added in 1954 making the building free standing as shown in Photo 2. This building on the edge of the gardens would make an excellent site for a FJ museum/interpretive centre.

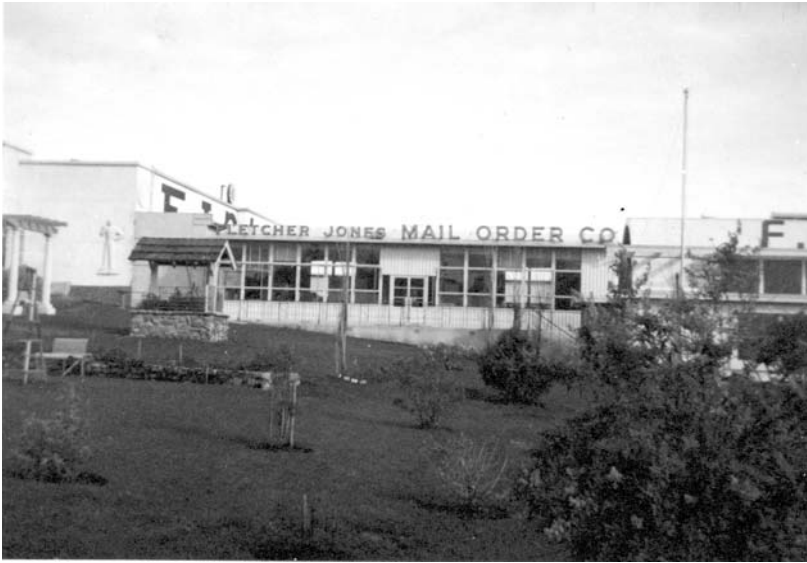
Photo 3

The British prefab building was erected to house our mail order company and accounting office. The building aligned with the eastern end of the Quonset hut and was 14'3" away from the west wall of the kitchen.

**Current State:** The hut which is built of aluminium has not been altered except for a door in the south side. The 1<sup>st</sup> floor canteen extends over part of the building.

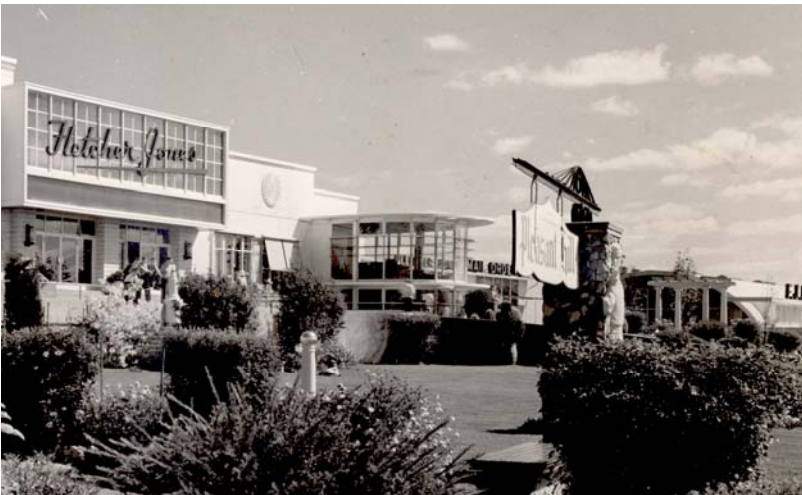
The Round Room was built in June 1951. It provided additional canteen space required as a result of increased staff numbers. The two levels were connected to the kitchen through servery hatches. Access to the upper level was from the existing canteen. The lower level was accessed through doors from a terrace

outside the Mail Order building. Internal stairs (non-compliant) were built to the lower level later.

**Current state:** The Round Room needs major restoration work to the exterior fabric. Consideration needs to be given with regard to access to the two levels.

The round room can be seen in Photo 21. It was originally the canteen annex built in 1951. (page 4). Thought should be given to the access to the two levels as current staircases are unsatisfactory. The internal staircase to the lower level is non-compliant. The external condition of this 55 year old timber structure is very poor. Consideration should be given to the refitting of the horizontal sun shades that were shown in Photo 4 – page 4. The room is a hot house!

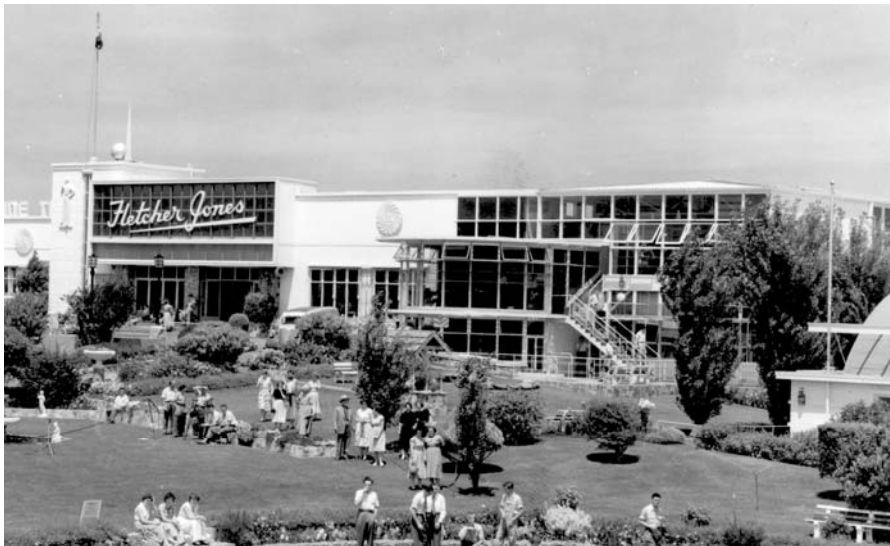
Photo 5

In 1955 a new canteen was built above the round room and part of the Mail Order building. The window layout matched that of the Mail Order building. The canteen extended through to the Lava Street boundary with access stairs at both ends and main internal stairs linking the new space with the 'old canteen' in the area of the original kitchen<sup>4</sup>. A new kitchen was built as an annex at the south west corner of the new structure.

Because of existing buildings underneath, the canteen toilets (on the east side) had to be elevated above the canteen floor. This second level was applied to all subsequent structures built on the east side (cool rooms, store rooms, office etc.) The outcome of all of the above was a building with a 'garden' elevation that was very pleasing and harmonious but an internal arrangement that was not ideal.

**Current state:** The canteen was built by our engineering staff above a menagerie of ex Darley and other buildings. As all of these buildings were essential and functional, the canteen was built on pipe columns<sup>5</sup> above the other structures which remain in some form today and add to the reputation of Pleasant Hill being a 'rabbit warren'.

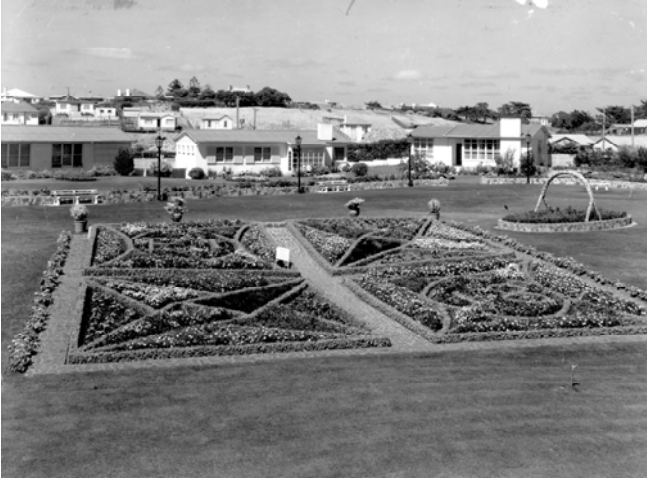
Photo 6

This photograph shows the three houses set behind the gardens. The house on the left<sup>8</sup> was moved to the 'Pleasantville' hostel site to free space for the building of the Skirt (Women's Wear) Factory – see Page 10.

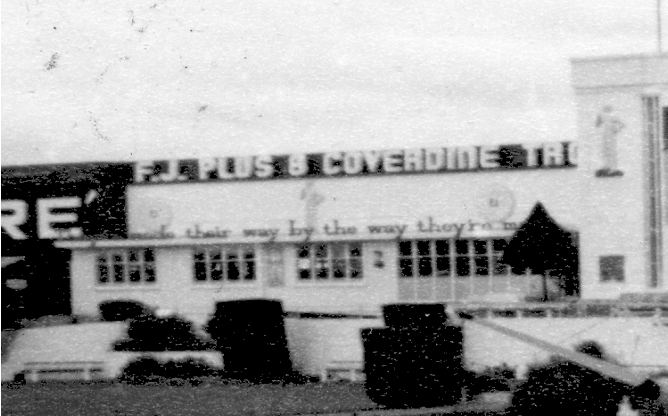
Photo 7

In 1958 the cutting room wall was rebuilt 6' to the north and the windows layout changed – compare layout with Photo 1. The top parapet and sign remained and new signage placed above the fascia of the extension.

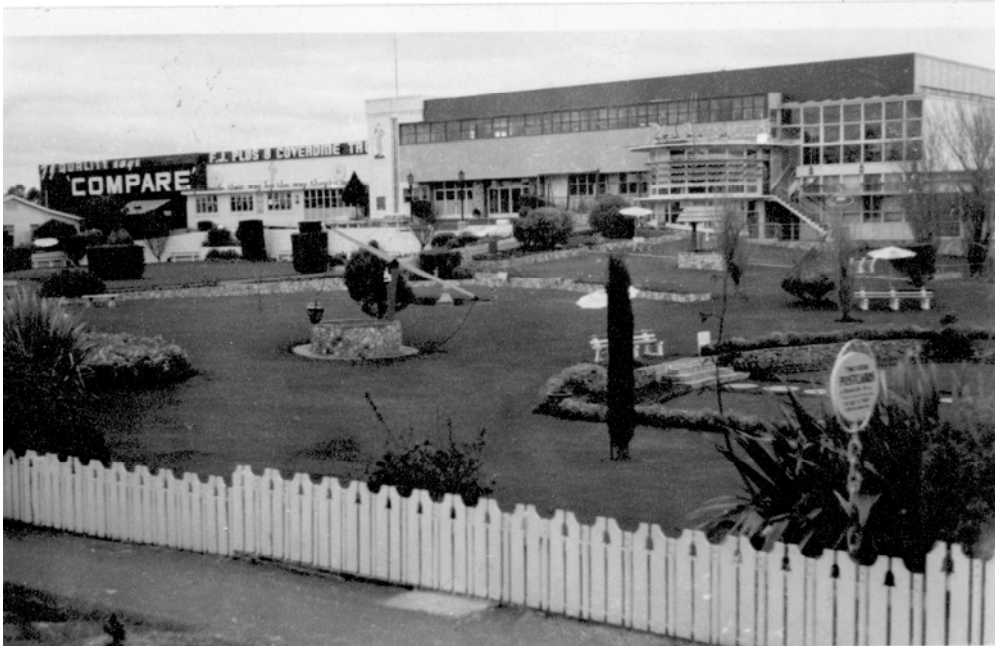
Photo 8

In 1959 a 1<sup>st</sup> floor level was constructed above the original canteen as a skirt pleating and sewing space. The extension was effectively a continuation of the original articulated glass sign (Photo 1) and continued across the top of the round room to the new canteen. This extension required the demolition of the roof of the first saw tooth bay of the machine room (old officer's mess) and the construction of a new roof. The old canteen, an area occupied by Pleasant Hill printers since 1956, was extended into the machine room area to provide additional office space.

This space was subsequently converted into administration offices.

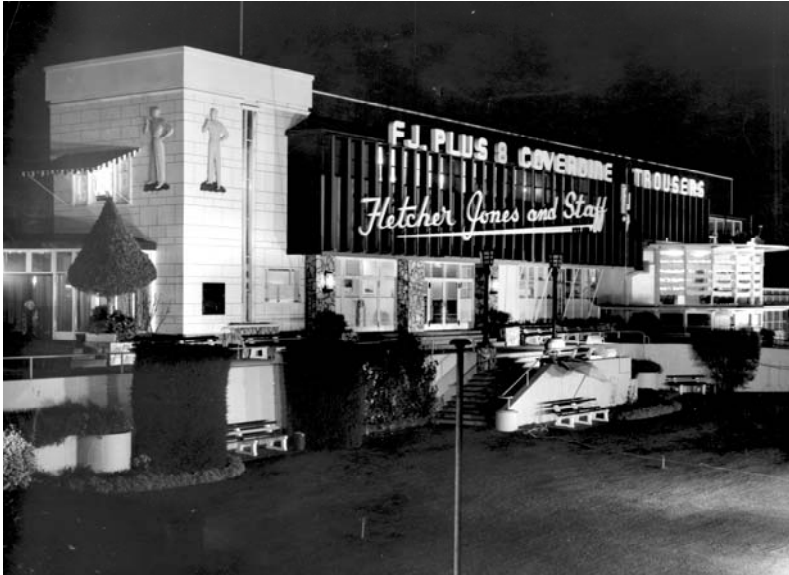
Photo 10

In 1960 the louvre treatment that had been previously introduced on the factory extensions to the east was added to the new façade of the main building. The colour was navy blue, later called 'FJ blue' by Dulux.

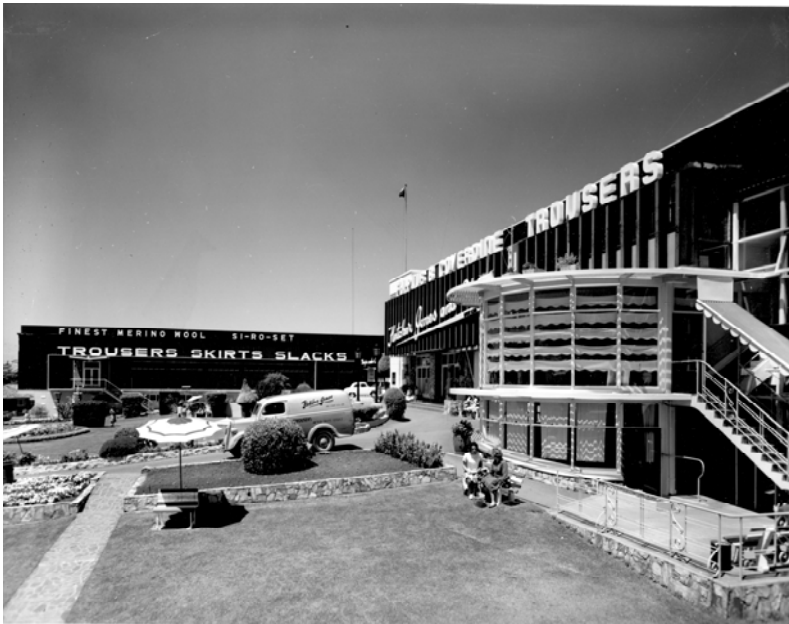
Photo 11

The FJ blue extended over the new cutting room and fabric warehouse buildings.

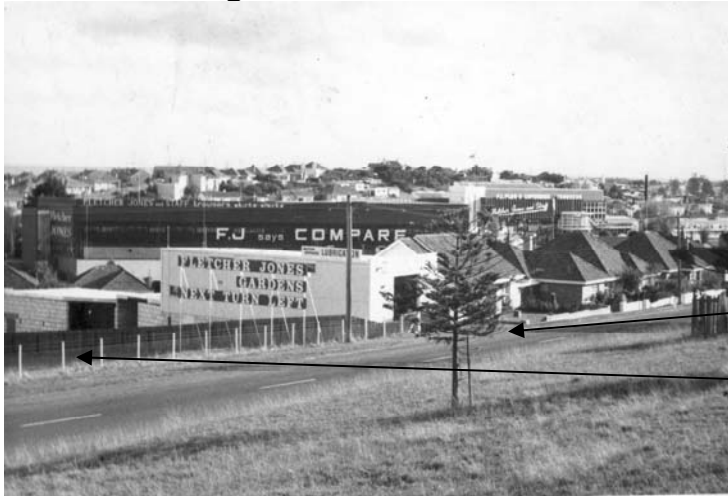
Photo 12

By this time the factory had extended to the eastern boundary of the site along Flaxman Street. The blue colour 'tied' the buildings together. The advertising signs were still significant. Note the size of the Norfolk Island pines! The Fletcher Jones Gardens sign in the near foreground was placed on Jukes Floral Farm land purchased by the company as a future option for cutting room expansion.<sup>9</sup>

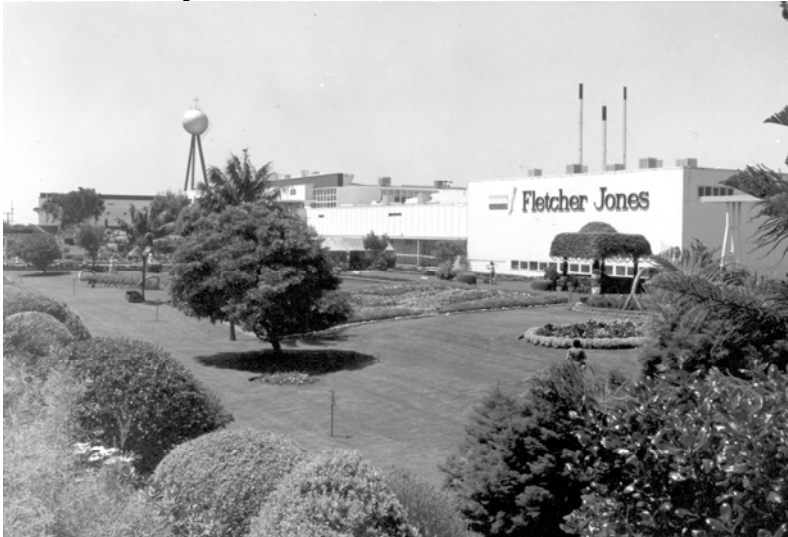
Photo 13

In 1973/74 a new Women's Wear Factory was built on the designated land to the west. One house was removed. A covered way built in front of the Quonset hut. White 'low maintenance' material was used. A 'new look' for Pleasant Hill.

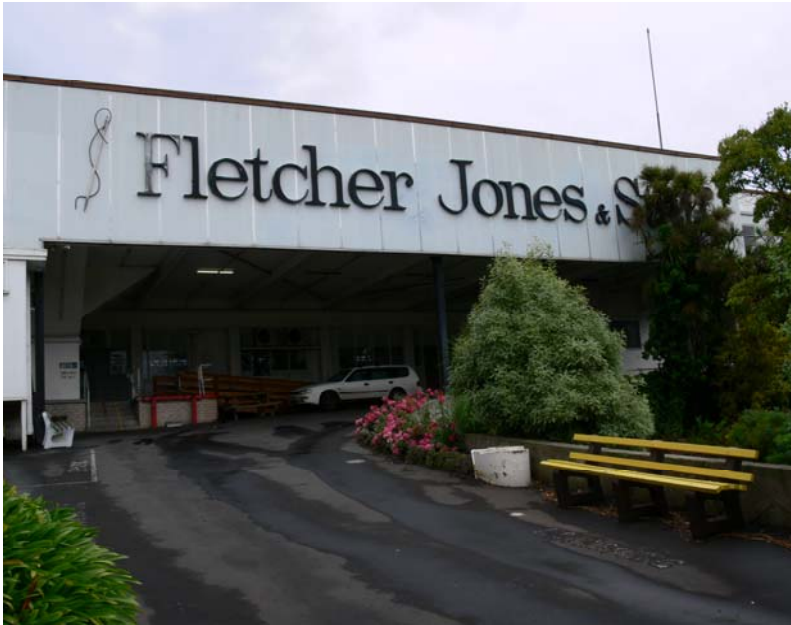
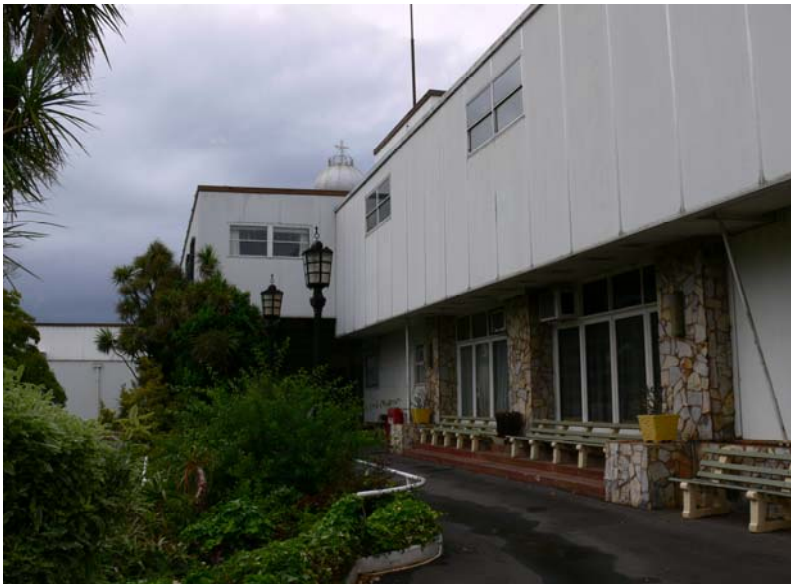
Photo 14

In 1974 a 'head office' was built consisting of the Managing Directors and Production Directors office together with senior management offices and secretariat, board room, library, and meeting rooms. This extended over the car park and connected to the main office across the front of the tower.

The white colour scheme was continued into this area and the blue louvres removed. A blue parapet remained. See Photo 16 – Page 12.

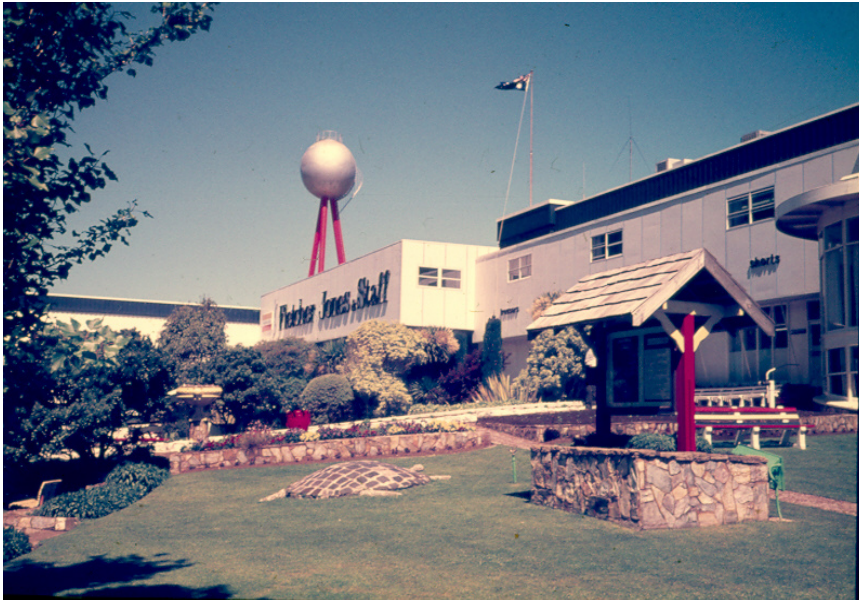
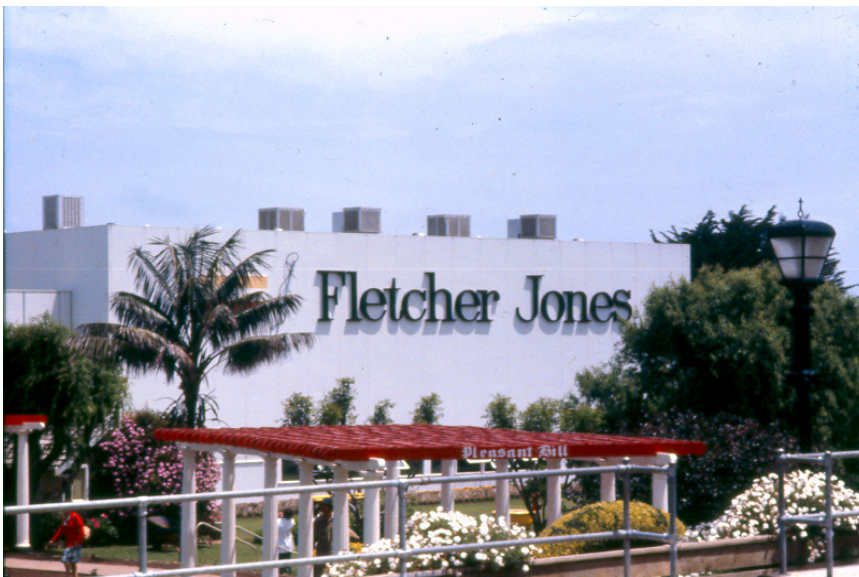
Photo 16

Pleasant Hill remains largely unchanged since these photos were taken. Windows were inserted in the north face of the Women's Wear factory for a new design mezzanine in the early 80's. The only main change has been the lack of building maintenance for the last 15 years.

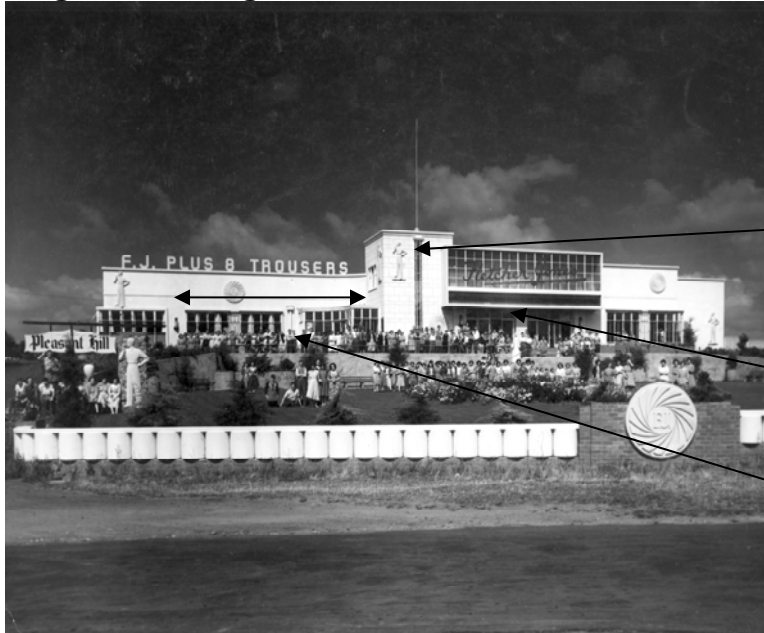
1. Reinstatement of the upper level of the original tower, north and east elevations (exterior only).
2. Reinstatement of the Fletcher Jones sign adjacent to the tower.
3. Reinstatement of the main section of the ground floor façade of the original cutting room including the curved entry, to the extent shown with the arrows.

1. The upper level of the tower can only be reinstated (rebuilt) after the demolition of the Executive office extension 1974 (photo 14 & 15 – page 11) together with the passageway connecting this extension to the main office (photo 15).
2. The reinstatement of the Fletcher Jones sign as shown in Figure 2 can only occur with the removal of all or most of the face of the first floor extension done in 1959. (Photo 8 – page 8). The boxed sign could then be rebuilt.
3. The reinstatement of the original cutting room façade can only occur after the demolition of the Executive office extension referred to in 1. above. The cutting room windows have been rearranged and relocated as part of the 1958 extensions (photo 7 – page 7). The current arrangement is shown in the Photo 18 – Page 14.

The recommendations do not make it clear that the above reinstatements are only possible after significant demolition of the existing structure. Very little of the original structure is in existence. The construction of a new staircase in the tower and the removal of the tall window fundamentally altered the structure.

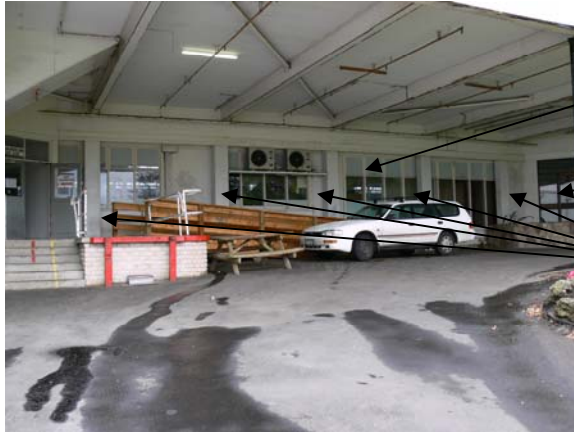
Photo 18

Underneath the Executive offices.

Relocated and rearranged windows

Altered front entrance

Supporting columns for Executive offices

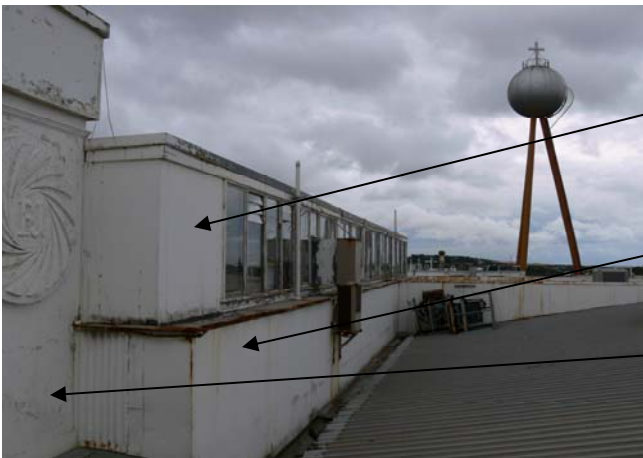
Photo 19

The original 1948 parapet above the windows of the cutting room is probably still in existence but the windows have been moved as detailed above as a result of the 1958 extensions (photo 7 – page 7).

Executive office extension 1974

Original cutting room parapet

South face of Tower

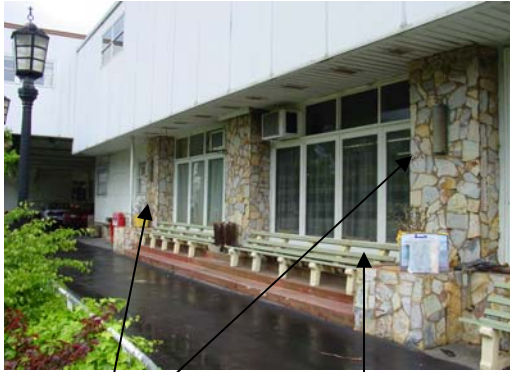
Photo 20

Lights not original

Original Doors

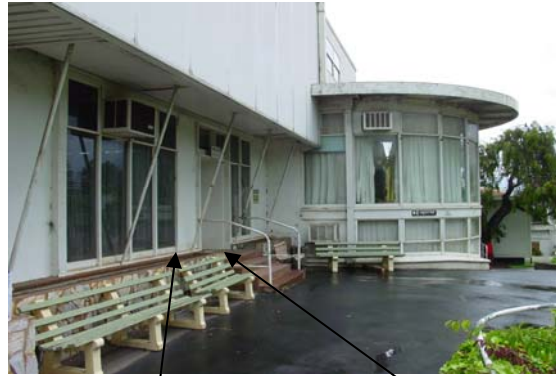
Photo 21

Wrought Iron feature missing

Windows reinstated  
Door removed.

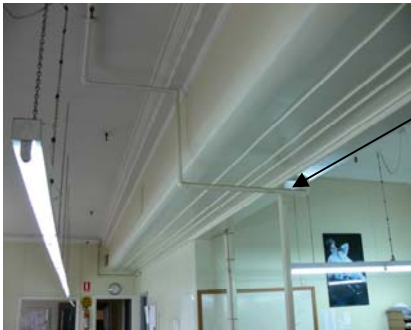
Photo 22

South wall of original canteen should be reinstated as shown in 1948 photograph.

Kitchen in 1948 is where stairs are to 1<sup>st</sup> floor canteen today.

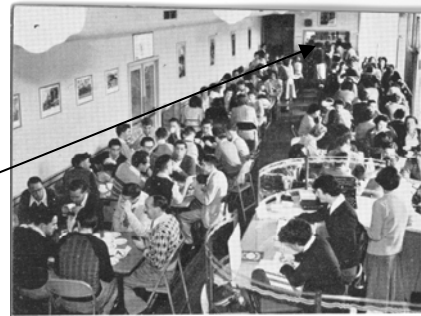
Photo 23

#### 1948 Photo

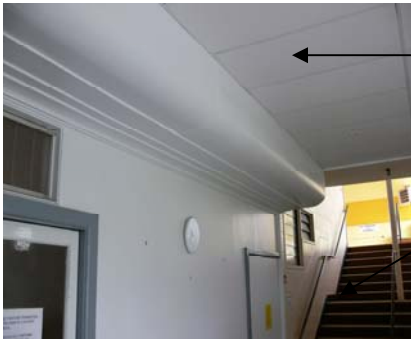
Photo 24

Suspended ceiling – recent addition

Stairs to Canteen

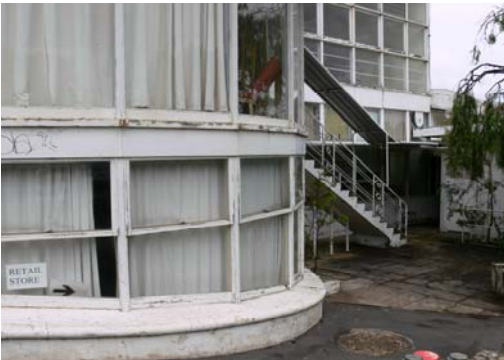
This whole area is very depressing. Photo 26 shows the deteriorated state of the Round Room and Photo 27 the Bristol Hut. If the first floor canteen north face is to be preserved then I accept the recommendation.

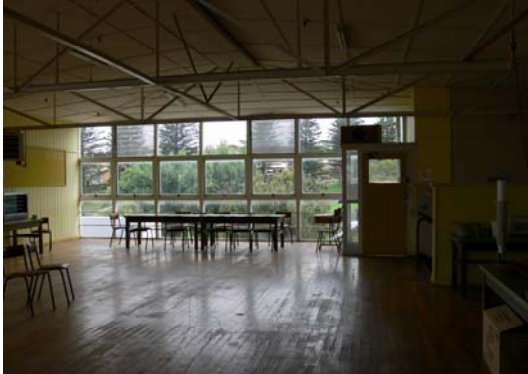
Photo 28 shows the northern end of the canteen overlooking the gardens and the door leading to the external staircase shown in Photo 26.

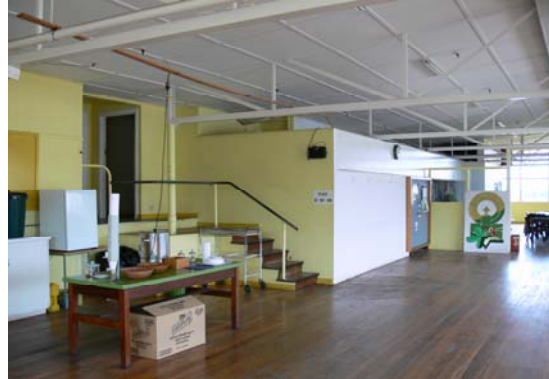
Photo 29 shows the eastern side of the canteen looking south showing the awkward levels referred to on page 5 with regard to toilet facilities.

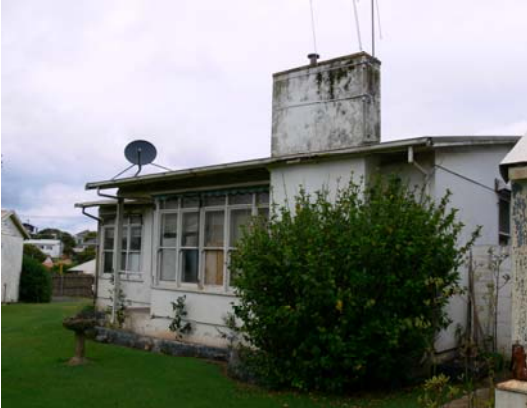
Photo 30

## Age small homes today.

There were three homes. One was moved in 1973 to make room for the Women's Wear factory. The only reason the other two houses remain on site is that expansion of Pleasant Hill was limited by our inability to get staff in Warrnambool in the early 70's and all manufacturing expansion was taking place in Mt Gambier. Staff numbers at PH in 1973 were 404 male and 632 female - total 1036!

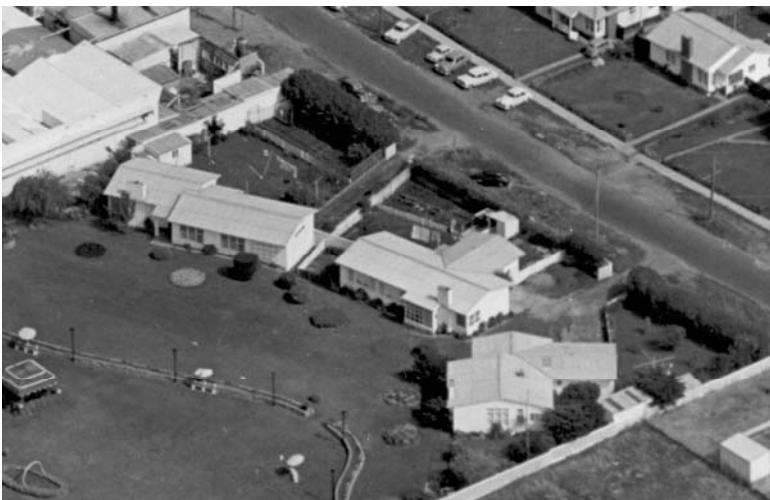
Much has been made of the fact that Fig 1 on Page 6 shows gardens to the south of the three houses. The reality was that each house had back yards with fences, sheds, hill's hoists, vegetable gardens, and woodheaps! See Photo 32 taken in 1962.

Note the garden umbrellas – they were made by the plumbers and painted by the painters.

The fences on the western and southern boundaries were constructed from recycled army hardwood tent poles set between top and bottom rails.

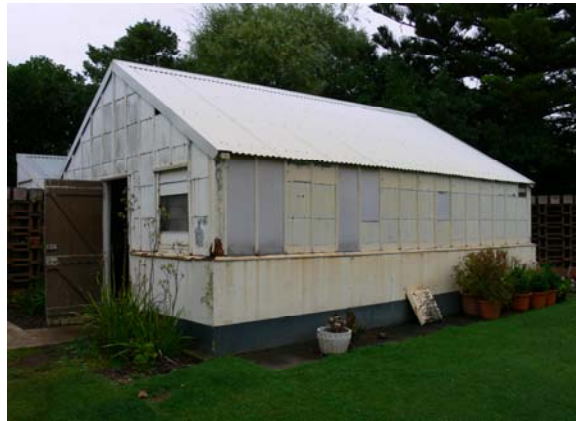
Photo 34

After the peacocks departed in 1967 the 'peacockery' was converted into a glass house (Photo 34) and then became the gardeners shed after the original shed burnt down. In my opinion there is no reason why this building should be retained and nor is any reason given.
